CAPITAL RESERVE ANALYSIS
FOR
BIRCHWOOD
LAWRENCEVILLE, GEORGIA

PREPARED BY: ROBERT "NICKO" N. ROMEO, R.S.

JANUARY 2020

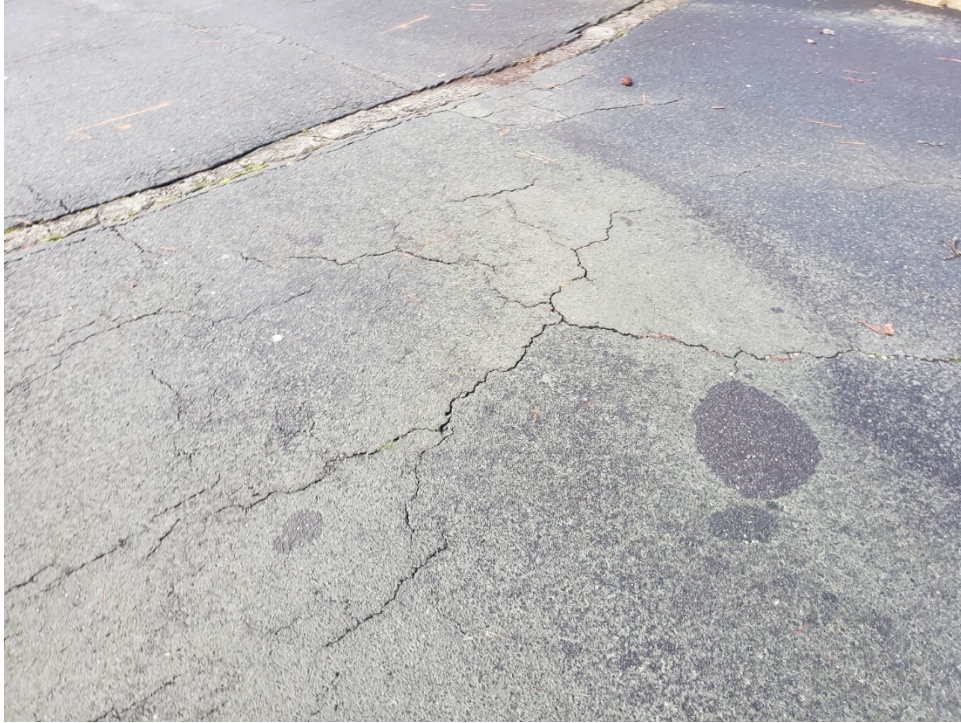
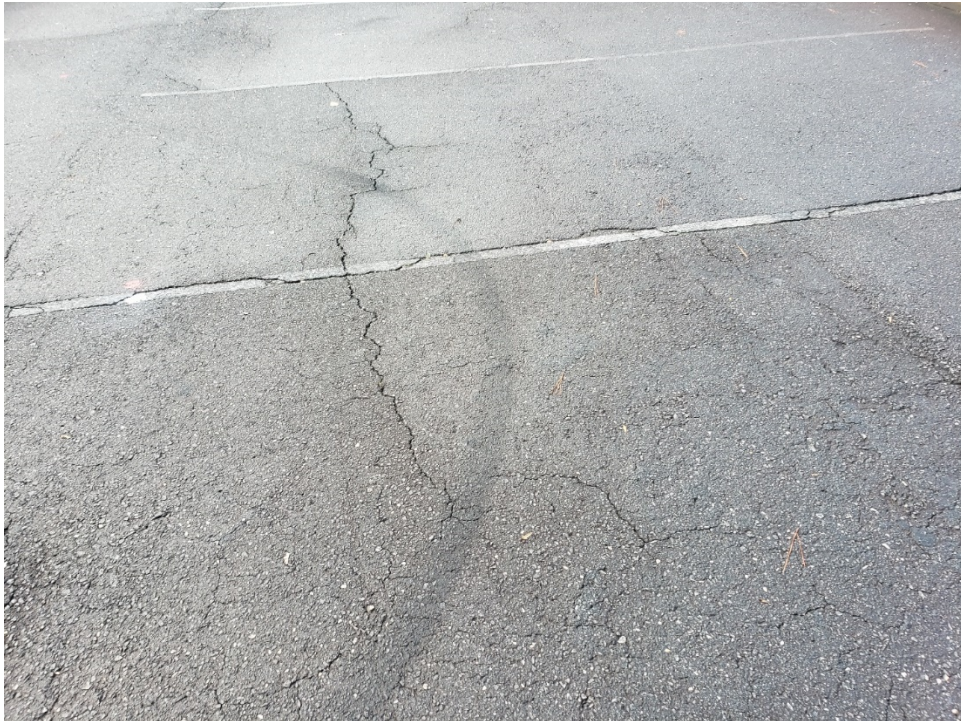
1. These items were found to be in good condition and well maintained. The useful life reflects the age and overall condition of the respective item.
2. **Parking Lot** – The parking lot at the amenity area appears to consist of a graded aggregate base, asphalt base course, and asphalt surface course. From our review, the asphalt pavement appeared to be in fair condition and experiencing normal wear and tear for the age of the asphalt. It should be noted that we did observe multiple linear and “alligatored” cracks at sections of the asphalt (reference photographs 1 & 2).

1. View of linear cracks at the amenity area parking lot.

2. View of linear cracks at the amenity area parking lot.

In order to prolong the useful life of the asphalt pavement, we recommend that the cracks be filled, and the pavement be sealcoated and striped every six to eight years. The useful life of asphalt pavement is approximately 20 years, after which, a new layer of asphalt should be installed. Prior to overlay, any settled areas should be removed, the base then re-compacted, and a new layer of asphalt course installed. It is recommended that a budget be allocated for the resurfacing of the asphalt with a 1-1/2" overlay every 20 years. We recommend that the asphalt surface be inspected approximately every ten years to determine if the condition of asphalt is adequate and if the useful life can be prolonged.

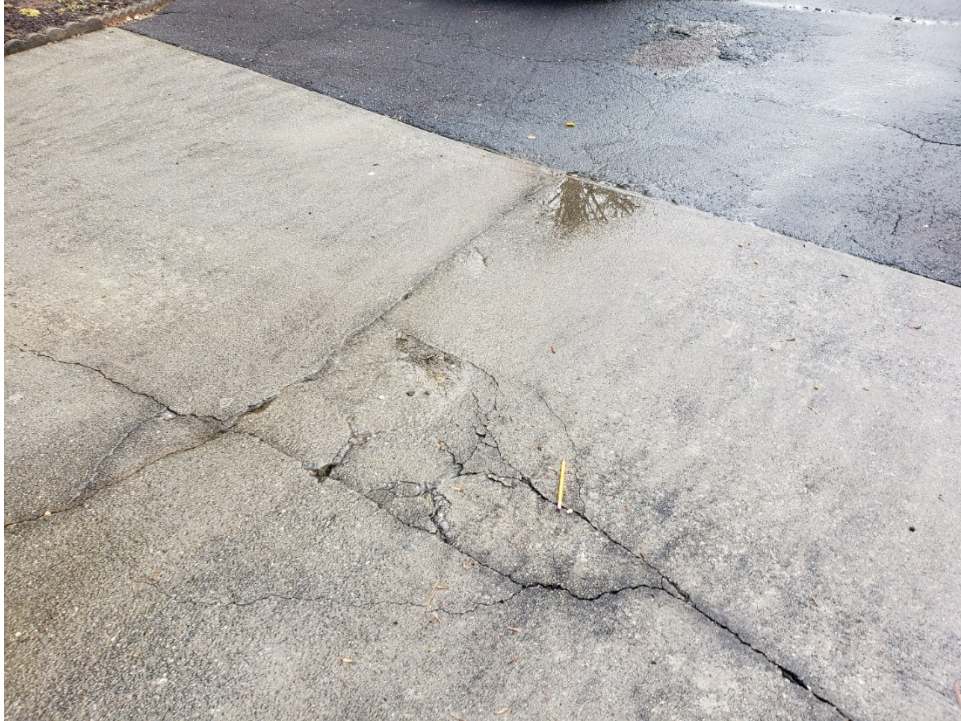
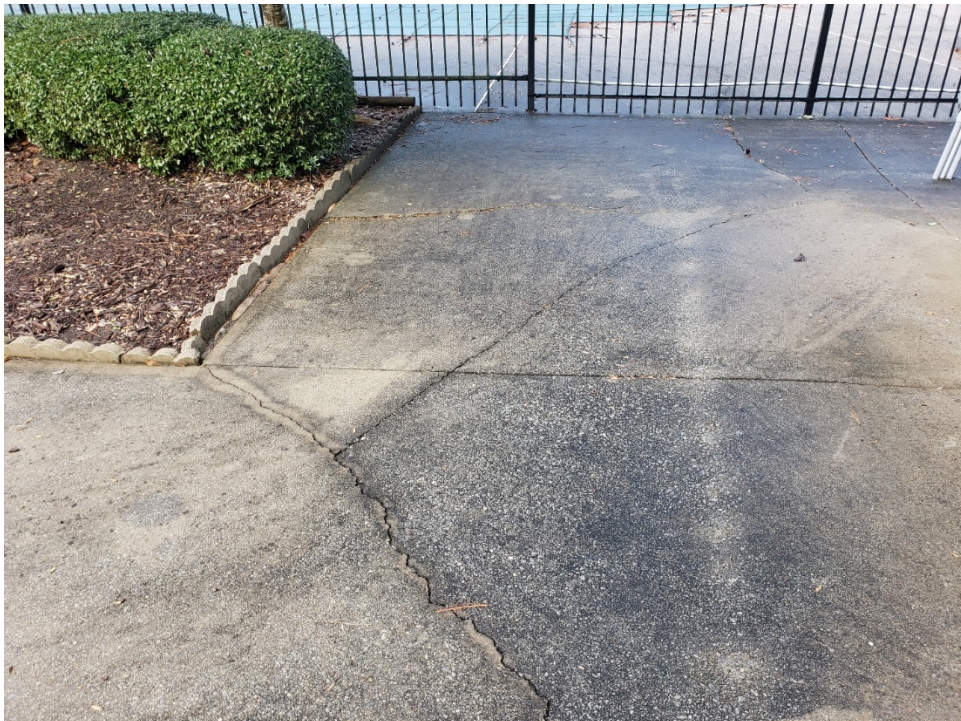
3. **Amenity Area Concrete** – There is a section of concrete that continues off of the amenity area parking lot into the amenity area connecting to the pool house, pool, and basketball court. From our review, the concrete appeared to be in poor condition with multiple large linear cracks and settled sections of concrete (reference photographs 3 & 4). The cracks and settlement appear to be the result of poorly compacted soils when the concrete was installed and possibly poor drainage.

3. View of cracked and settled section of the concrete.

4. View of cracked and settled section of the concrete.

Any sections of concrete that are settling should be monitored, and if they continue to settle, these sections should be replaced. We have provided a budget for the replacement of damaged, deteriorated, or settled sections of the concrete at the property. The budgets are provided every six years and the funding can be used when necessary, during the estimated useful life. The budgets are not for complete replacement of the concrete, only replacement of the sections that become trip hazards or safety concerns. Any vertical displacement at cracks that could potentially represent a trip hazard and liability should be replaced.

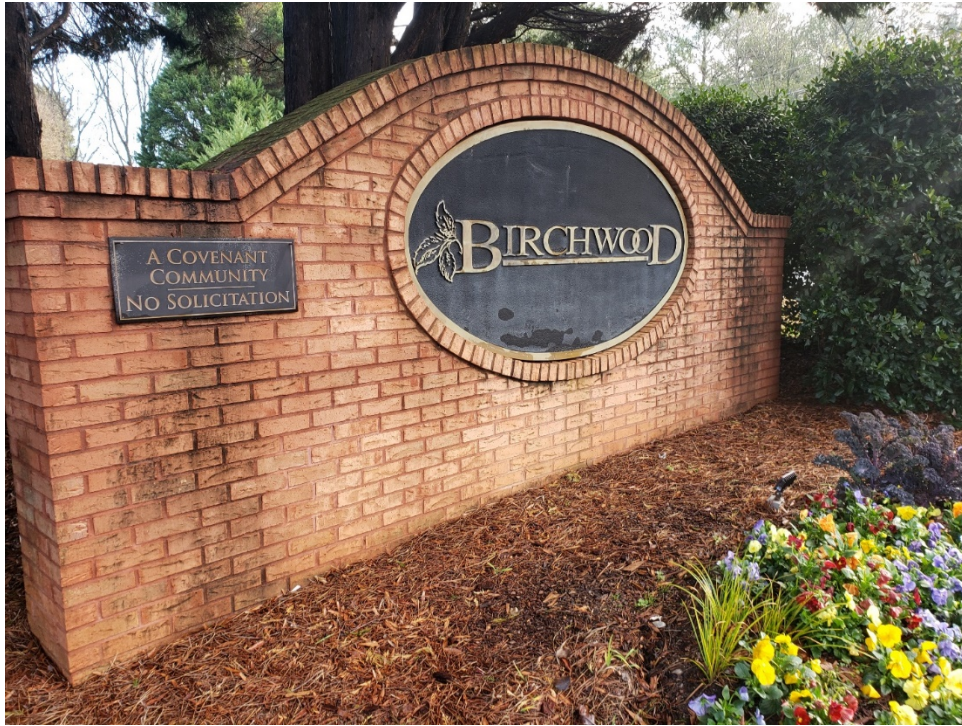
5. View of a typical entry monument and signage.

Any mildew growth on the monuments and grout joints may be power washed as part of regular maintenance for a better appearance. It is recommended that \$2,000 be allocated for the repair, cleaning, and tuck pointing of the entry monuments, signage, and entry fencing approximately every eight years.

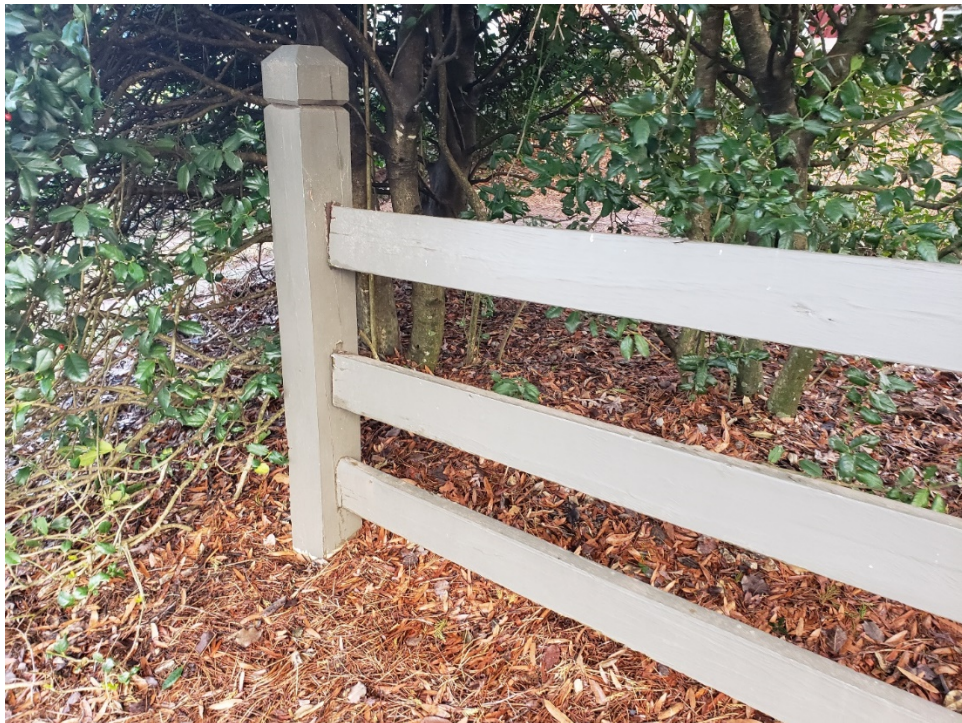
4. **Entry Monuments/Signage/Fencing** – The entry monuments and signage are located at the entrance to the property. The monuments consist of a brick veneer monument with painted inset signage. Along the sides of the monument are painted wood, ranch-style fencing. From our review, the entry monuments and signage appeared to be in generally good condition. We observed mildew and efflorescence at the brick monuments and should be pressure washed (reference photograph 5). The adjacent wood fencing was in fair condition; however, some of the horizontal members are rotating off the joist hangers and should be repaired (reference photograph 6).

6. View of typical entry fence. Note the rotating horizontal members.

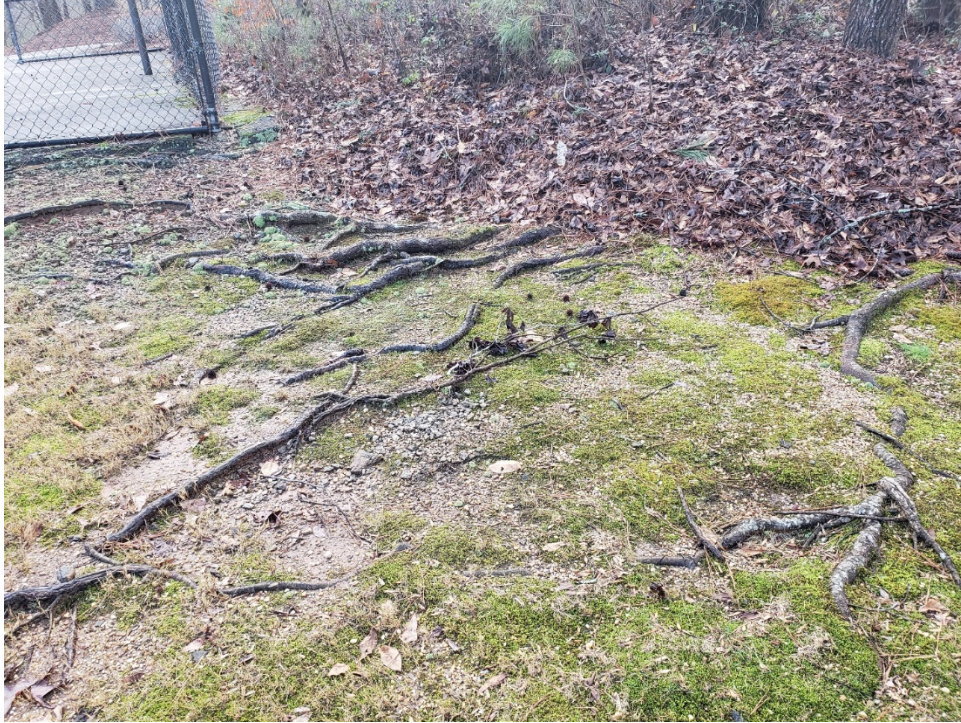
5. **Landscaping** - The landscaping at the common areas consists of small and large trees, shrubs, and common landscaped areas. From our review, the common area landscaping appeared to be in fair condition; however, we observed multiple exposed roots and sections of the basketball court that are being uprooted by the trees (reference photographs 7 & 8). If the trees and roots are not removed, the trees can continue to impact the structural integrity of nearby structures and materials. The appearance of the community is very subjective, as is the allocation of funds for the upgrade of the landscape materials. From our experience with similar communities, upgrading of the community landscaping is typically done every five years.

7. View of large exposed tree roots at the amenity area.

A budget of \$15,000 has been allocated for the replacement of any uprooting,

damaged or diseased shrubs and trees, trimming of trees, and upgrading of the landscaping every five years. This is not designed for yearly or routine landscaping or annual flower installation. All trees that are located within 10' of a structure should be removed or monitored to prevent any damage.

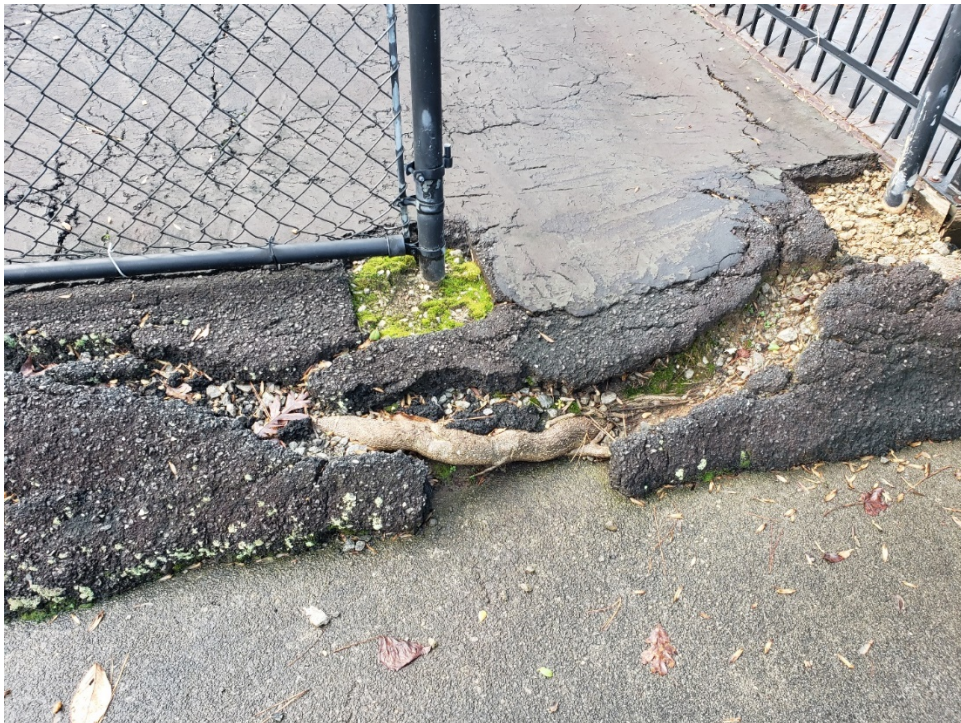
8. View of tree roots damaging a section of the basketball court.

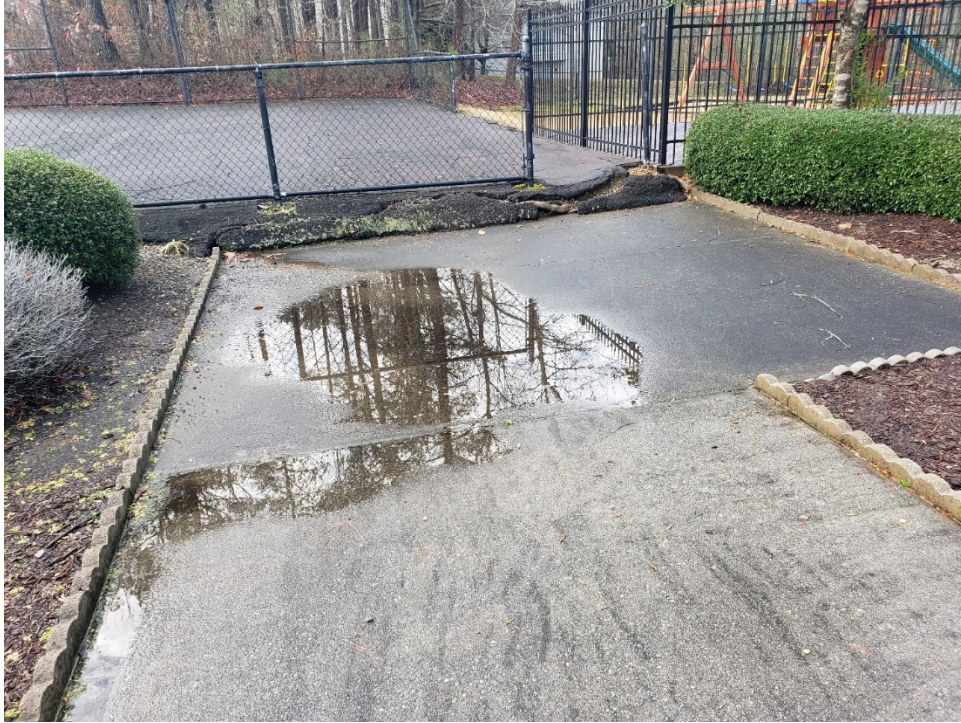
9. View of ponding water between the amenity area concrete and basketball court.

All areas that appear to have poor drainage, it is recommended that swales and river rock be installed to improve the surface flow of water, as needed. It should be noted that it is possible to install French drains in landscaped areas to further improve the drainage. A budget of \$5,000 has been allotted for the maintenance and repair of the stormwater drainage every seven years. The budget for the drainage may decrease over time as a result of proper maintenance.

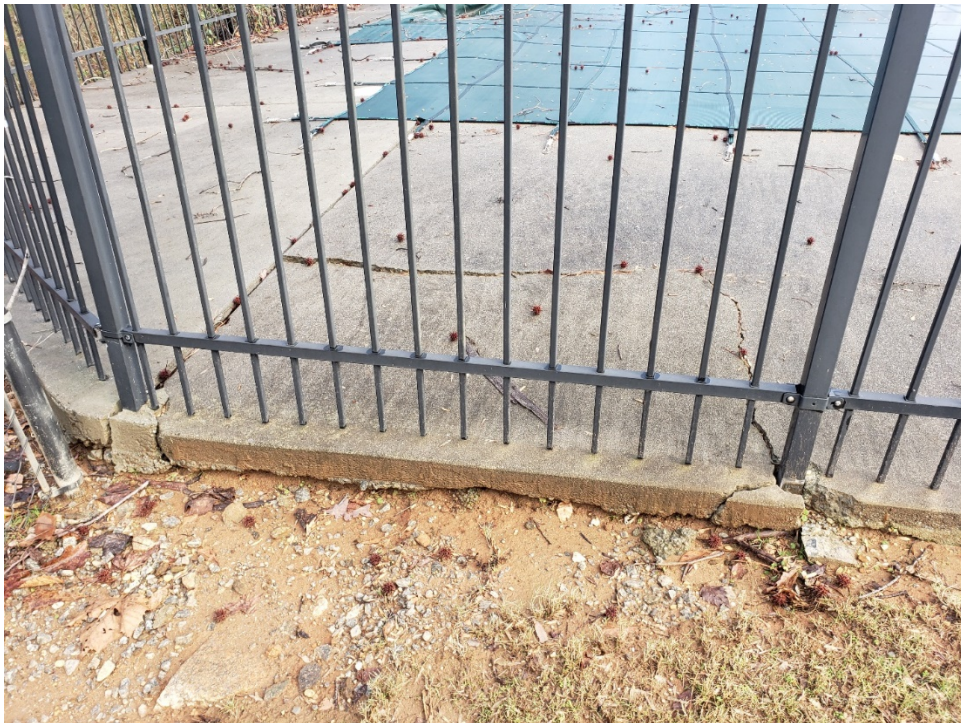
10. View of voids beneath the concrete pool deck as a result of poor drainage.

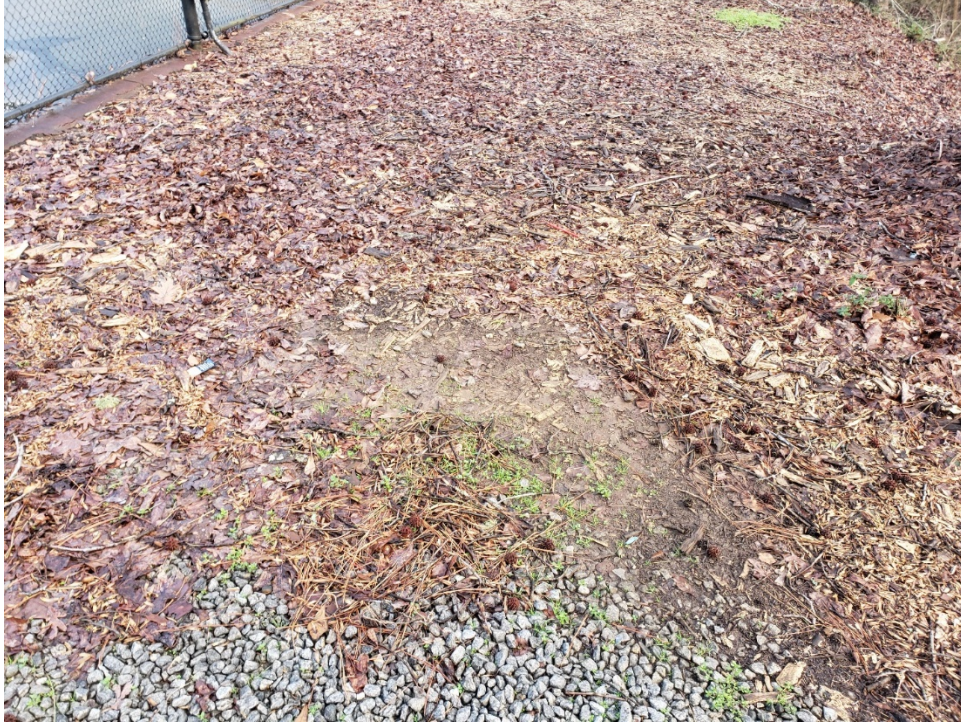
11. View of poor drainage adjacent to the tennis court.

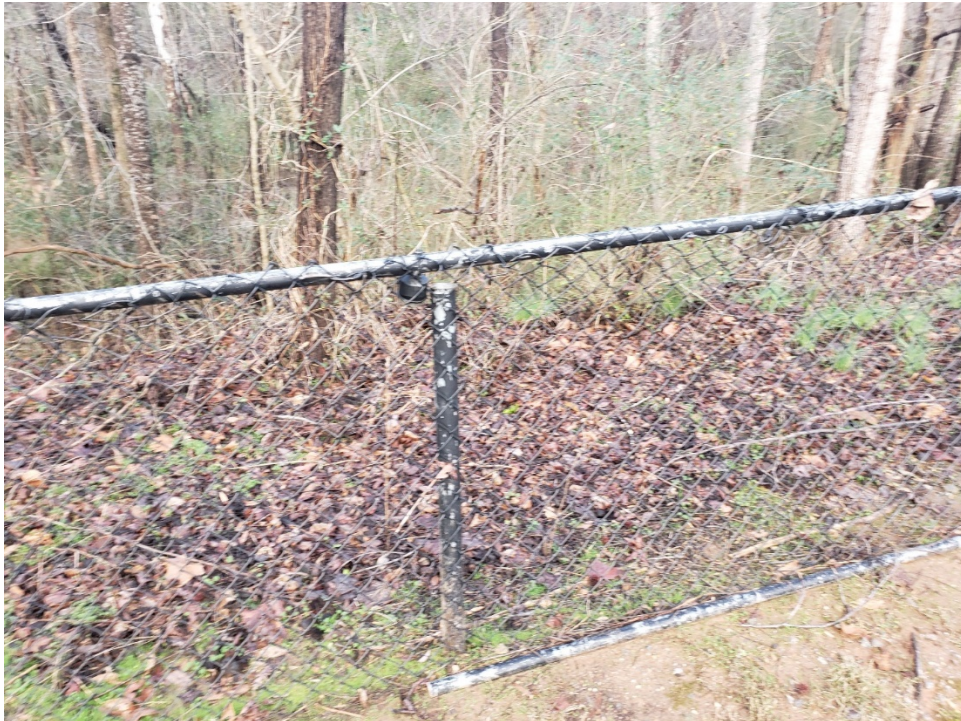
7. **Amenity Area Fencing** – The amenity area fencing at the property consists of a perimeter, painted chain link fence. From our review, the fence was in poor condition with chipped paint and damaged sections of the fence observed (reference photograph 12). It should be noted that the chain link fencing is not a structural member and is for aesthetic purposes only.

12. View of typical section of chain link fence that has chipped paint and is damaged.

It is recommended that \$3,000 be allotted for the repair, painting, and partial replacement of the amenity area fencing approximately every eight years.

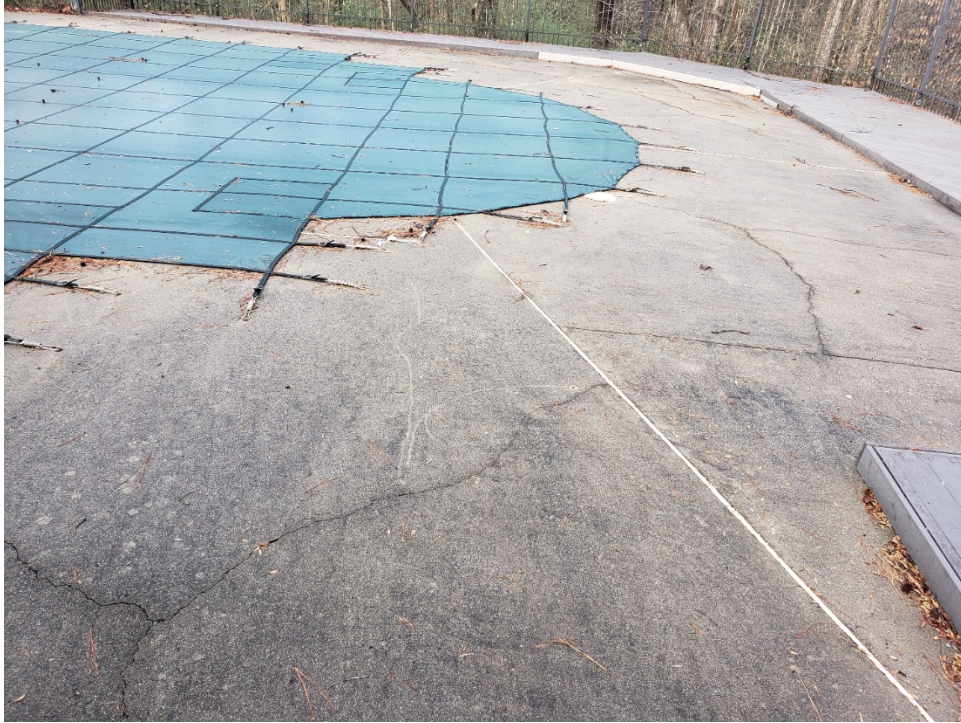
- The pool deck is exhibiting normal linear cracks typical caused by expansion and contraction of the concrete; however, it is recommended that these cracks be sealed and monitored for any movement (reference photograph 13).
- There are sections of the fencing that are damaged and/or are leaning (reference photographs 14 & 15).
- The biggest issue we observed is the condition of the wood decking. It appears that as a result of a combination of poor drainage, the installation of non-pressurized wood members, and poorly constructed members, there are multiple sections that are deteriorated and/or are failing (reference photographs 16-18). Based on our observation, sections of the decking are structurally unsound and should be repaired or replaced as soon as possible.

13. View of typical linear cracks at the pool deck.

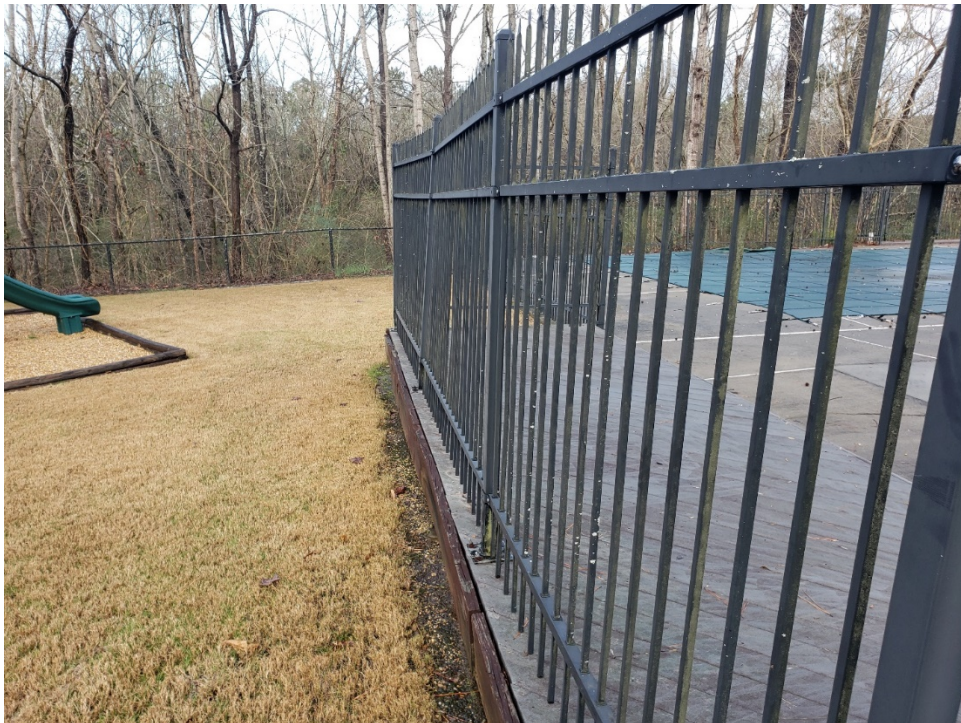
14. View of leaning section of the pool fence.

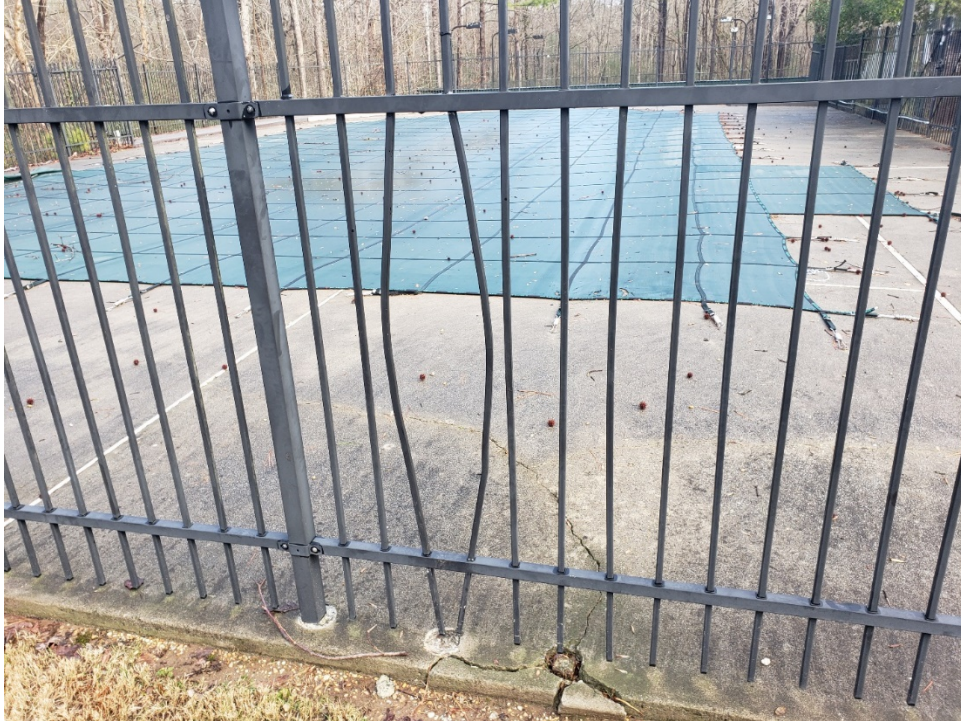
15. View of damaged section of the pool fence.

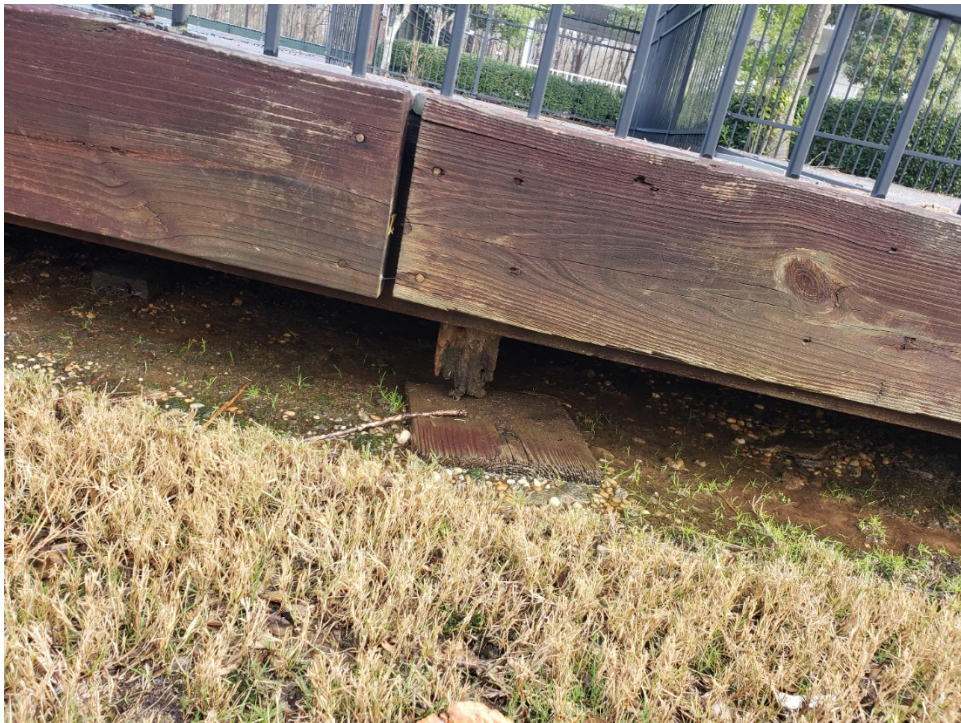
16. View of deteriorated band and 4x4 column at a section of the wood-framed pool deck.

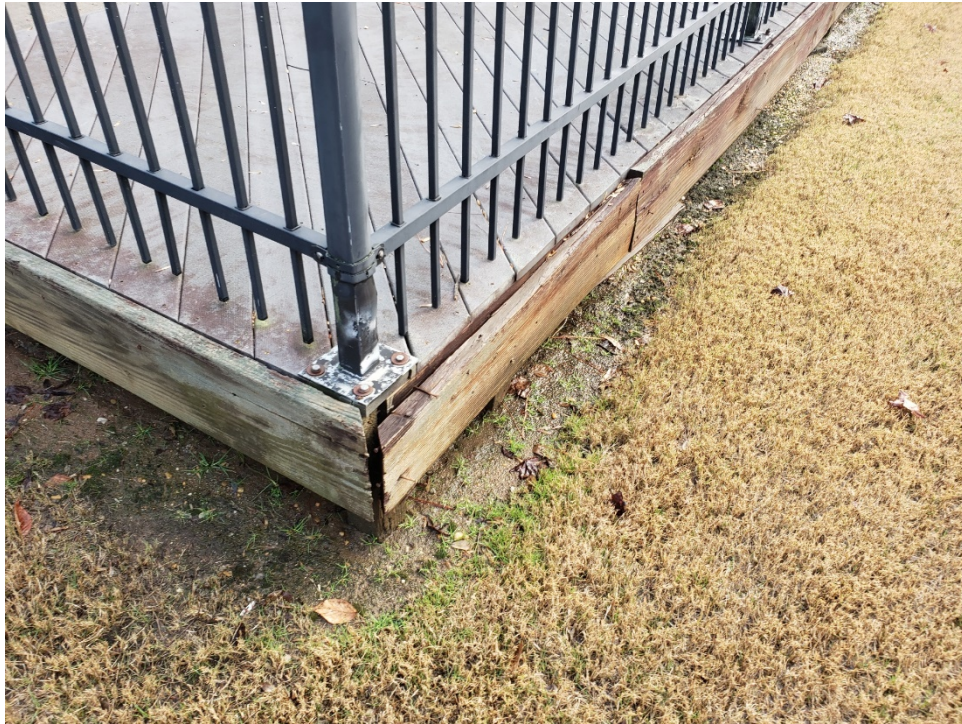
17. View of deteriorated band at the wood-framed pool deck.

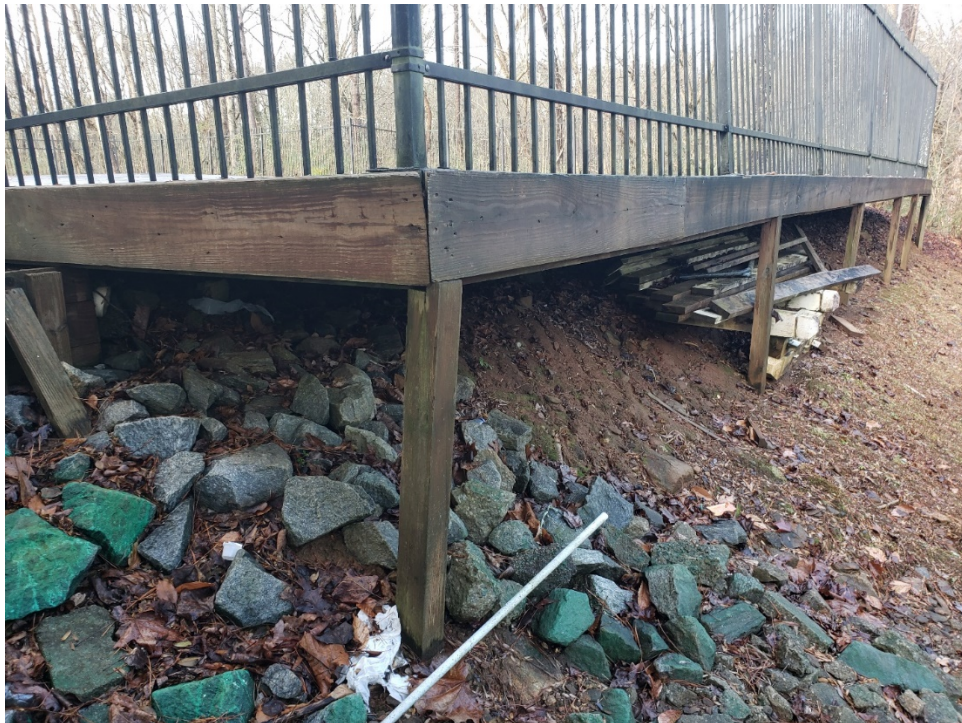
18. View of failing section of the wood-framed pool deck that should be replaced.

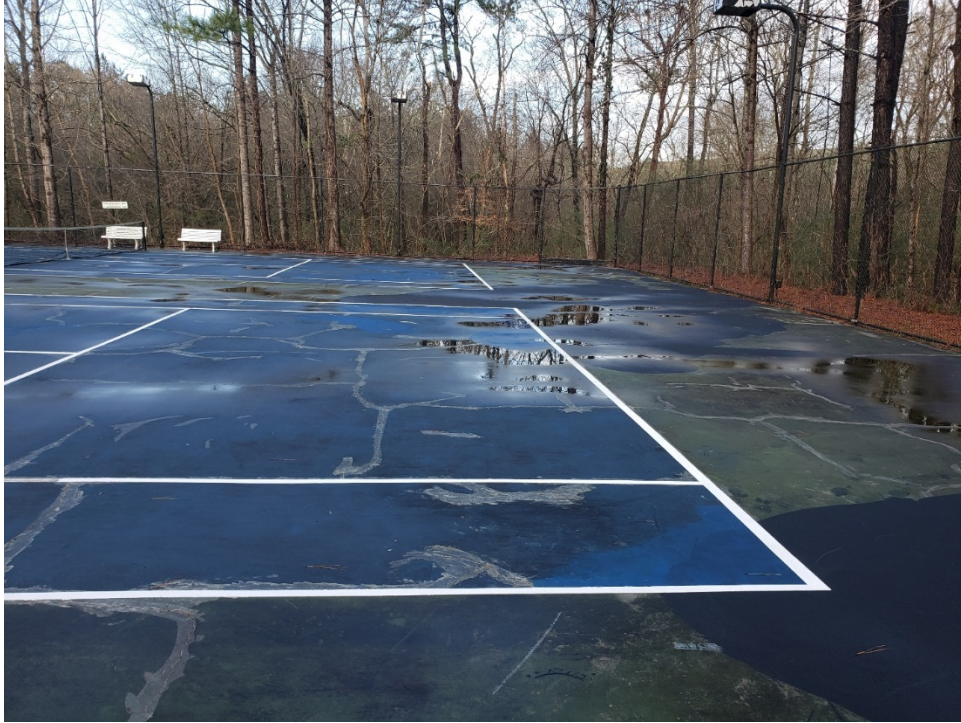
surrounded by a metal chain link fence. From our review, the tennis courts appeared to be in poor condition with multiple linear cracks that were patched, and ponding water observed (reference photograph 19). Based on the condition of the tennis court surface, it appears that the tennis courts are reaching the end of their useful life and should be replaced; however, as a result of current funding, resurfacing of the tennis courts should be completed first until a budget has been accumulated to replace both of the tennis courts and fencing.

19. View of ponding water and cracks at the tennis courts.

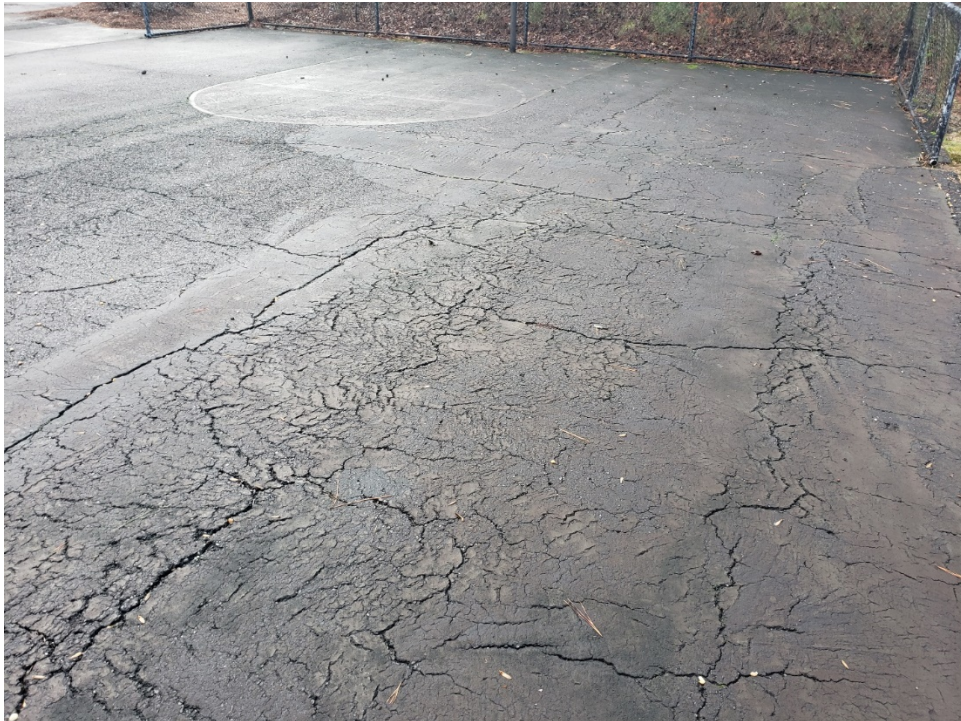
10. **Basketball Court** – The basketball court consists of a hard-surfaced court surrounded by a metal chain link fence. From our review, the basketball court was in poor condition with multiple cracked and settled sections observed (reference photograph 20). The Association may consider replacing or removing the court in the near future. The condition of the chain link fence was also in poor condition with chipped paint and damaged sections observed (reference photograph 21). It should also be noted that there is currently no goal at the basketball court.

20. View of multiple cracks and settled sections of the basketball court.

A budget of \$600 should be allotted for the painting and replacement of the basketball goal every nine to ten years. It is recommended that \$500 be allotted for the sealcoating, restriping, and repair of the court surface approximately every six years. It is also recommended that \$30,000 be allotted for the replacement of court surface and fencing every 20-25 years. If the Association decides to remove the court, all funding for the basketball court should be removed.

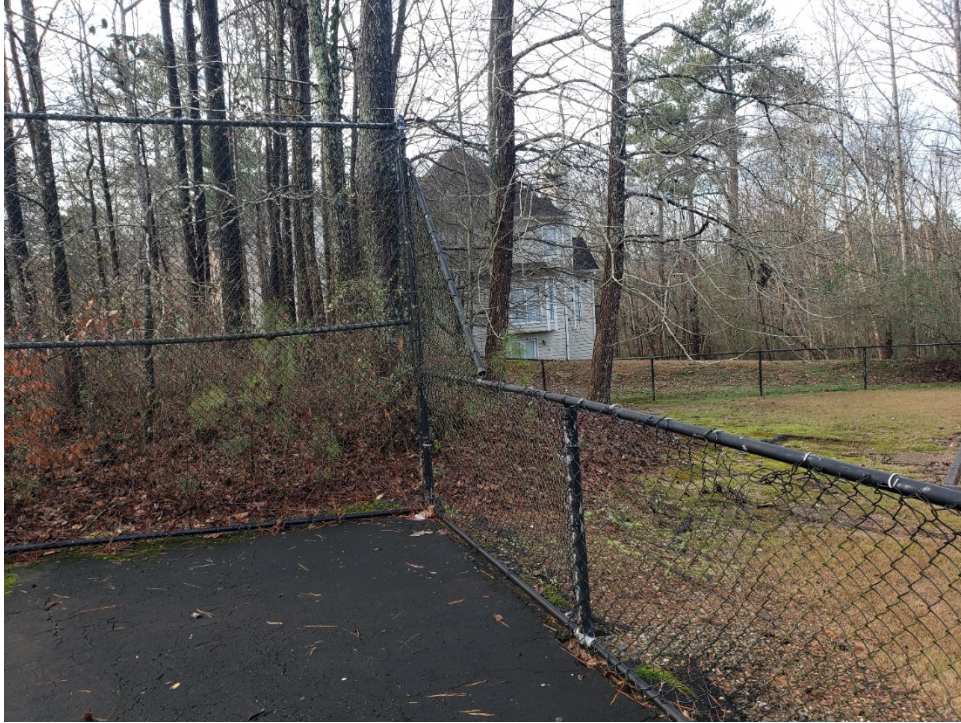
21. View of damaged section of the chain link fence at the basketball court.

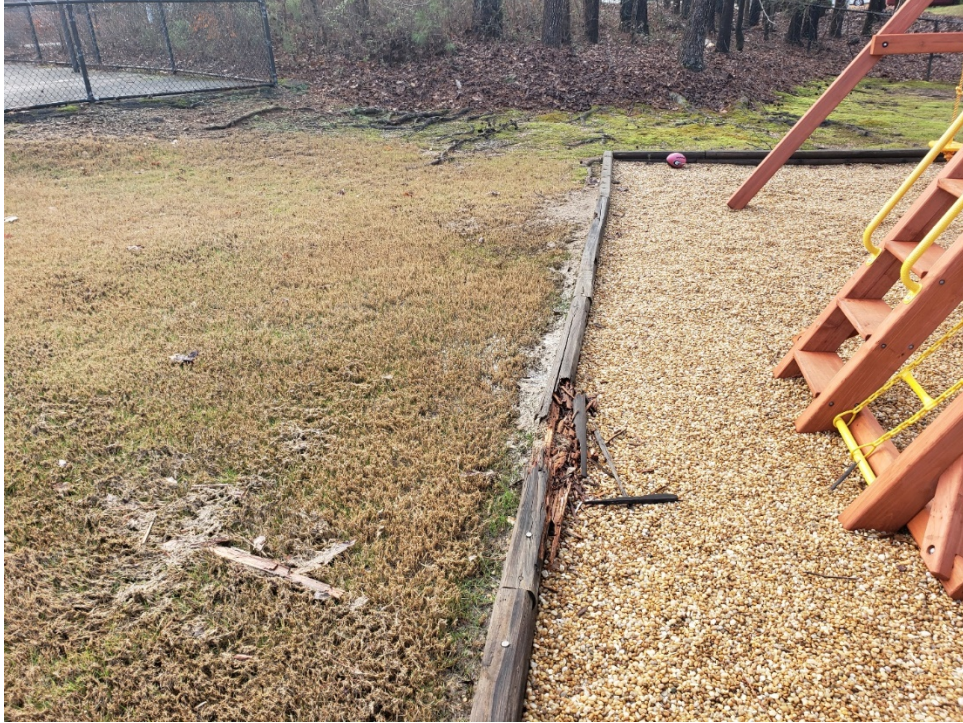
11. **Playground** – The playground equipment is located at the amenity area, adjacent to the pool deck. The playground equipment consists of a wood-framed structure with polyethylene equipment and slides, as well as a swing structure. It is our understanding that the equipment was replaced in 2019. From our review, the playground equipment appears to be in generally good condition with no remedial work required at this time (reference photograph 22). The border of the playground is deteriorated and should be replaced (reference photograph 23).

23. View of deteriorated playground border.

It is recommended that \$500 be allotted for the repair and partial replacement of the playground equipment every six years. It is also recommended that \$4,100 be allotted for the replacement of the playground equipment every 20 years. We also allotted a budget of \$2,500 for the one-time replacement of the playground border.

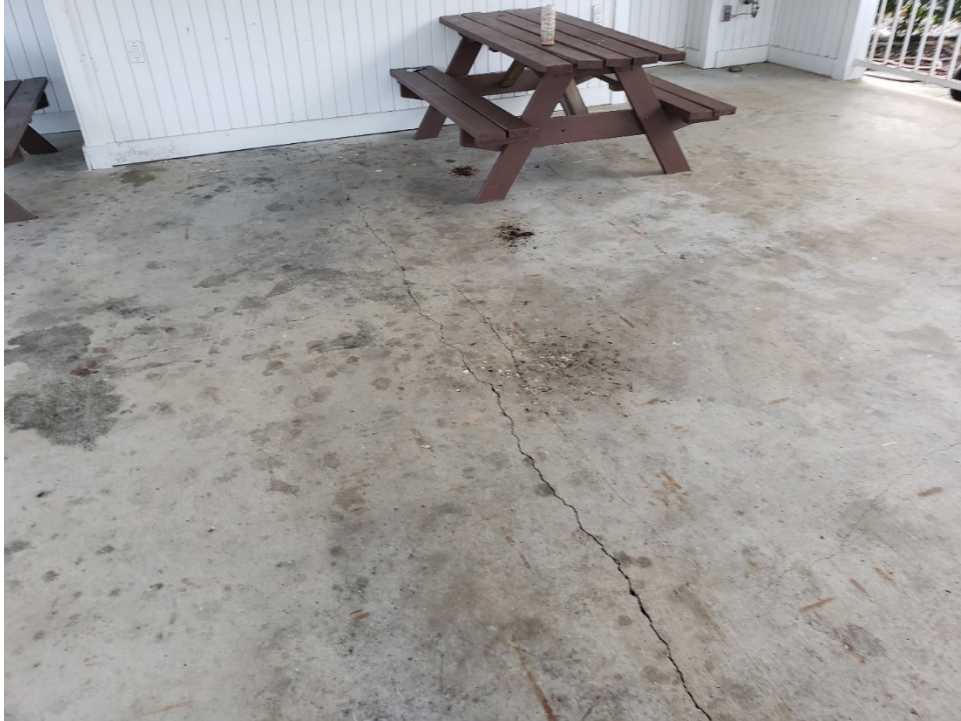
- There are small linear cracks at the concrete slab at the pool house (reference photograph 25). The cracks do not appear to be severe; however, they should be patched and sealed and monitored for any movement.
- The base of the steel columns at the pavilion section of the pool house are corroded (reference photograph 26). If not remediated, the corrosion of the columns can increase and result in the failure of the column.

25. View of typical linear crack at the pool house concrete slab.

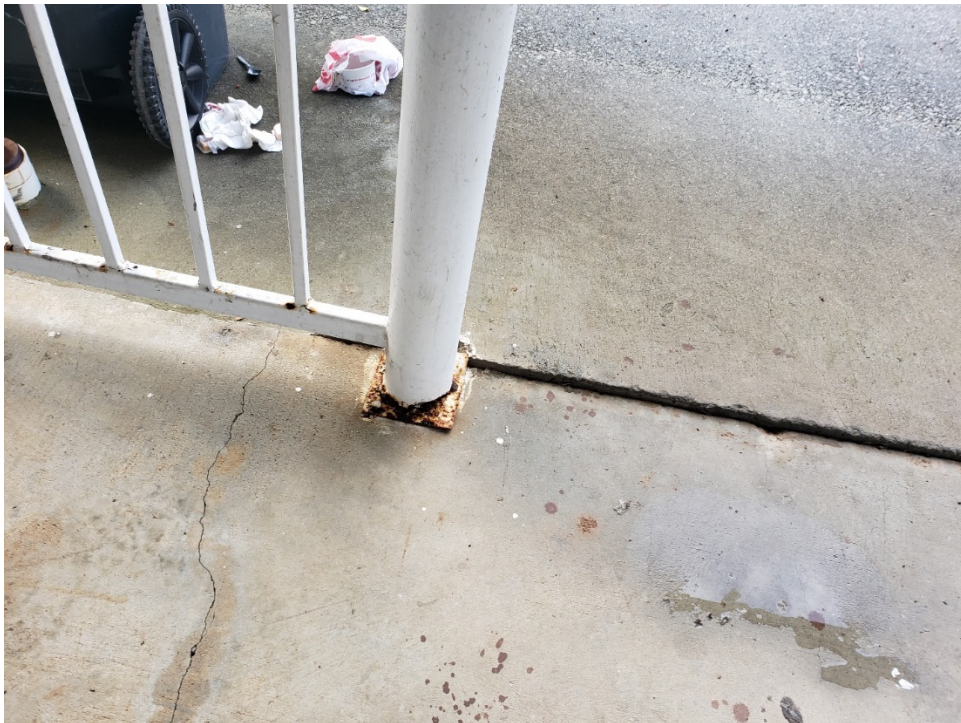
26. View of typical corroded pavilion column at the pool house.

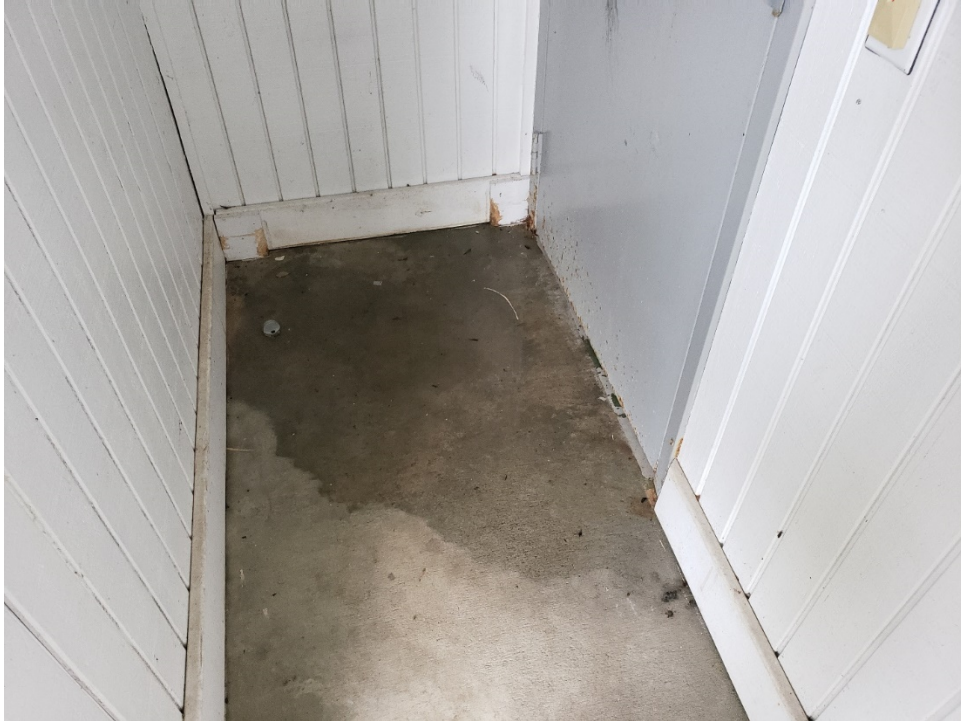
27. View of ponding water in front of the restroom doors.
